June 28, 2019 File No. 262018.063

Subject: Department of Natural Resources Washington Geological Survey,

School Seismic Safety Assessment Project, Contract No. AE 410 - Seismic Evaluation for **White Salmon Valley School District**

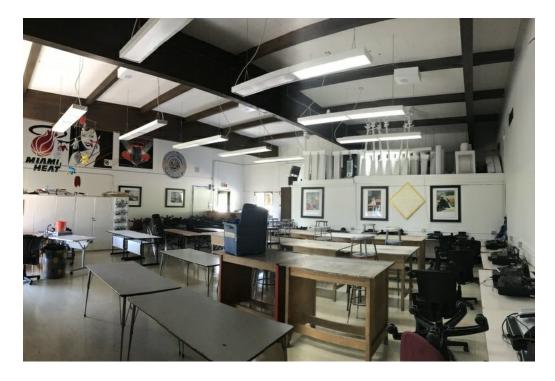
Figure 1-3. Northwest Classroom with Glulam Beam Roof Framing and Fall-Prone Contents

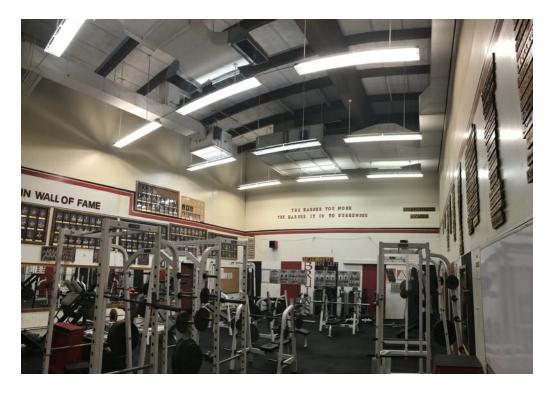
Figure 1-7. Weight Room at Lower Level with Suspended Mechanical Equipment

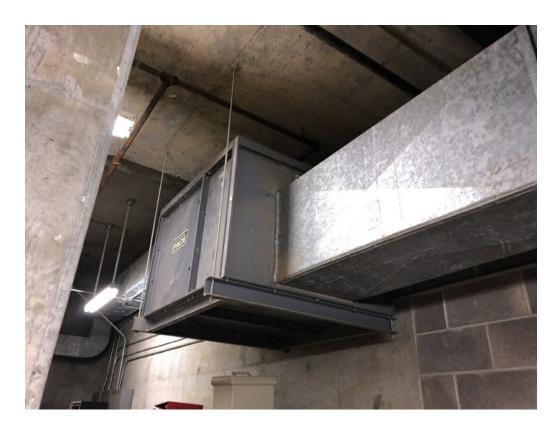
Figure 1-9. Suspended Mechanical Equipment at Lower Level

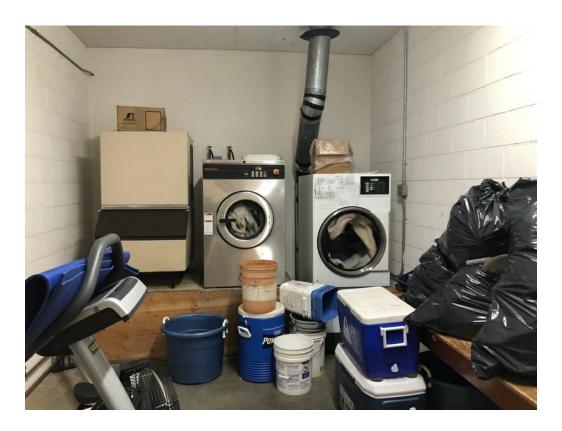
Figure 1-10. Unbraced Nonstructural Components, Typical Throughout

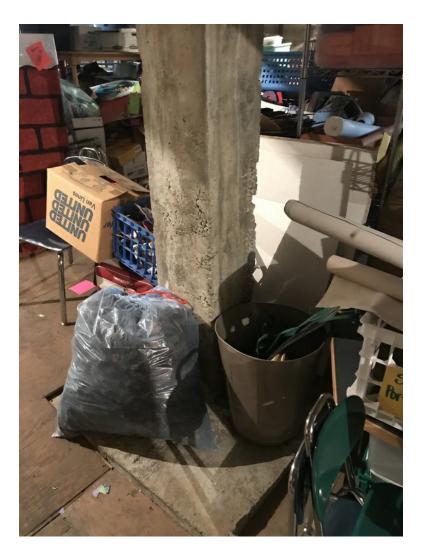
Figure 1-1. Deterioration of Concrete Columns in Boiler Room

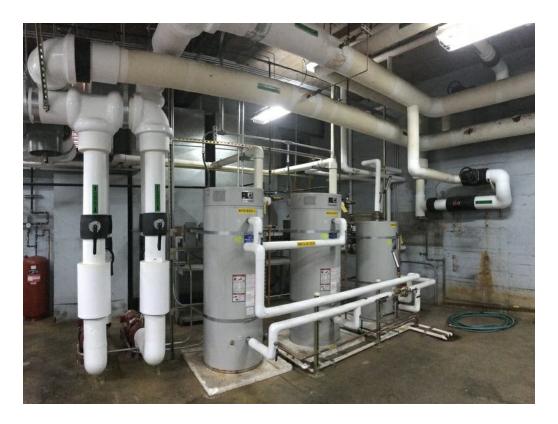
Figure 1-2. Unbraced MEP Equipment in Boiler Room

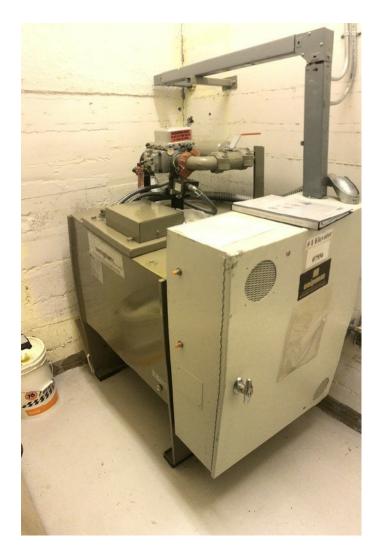
Figure 1-3. Unbraced MEP Equipment

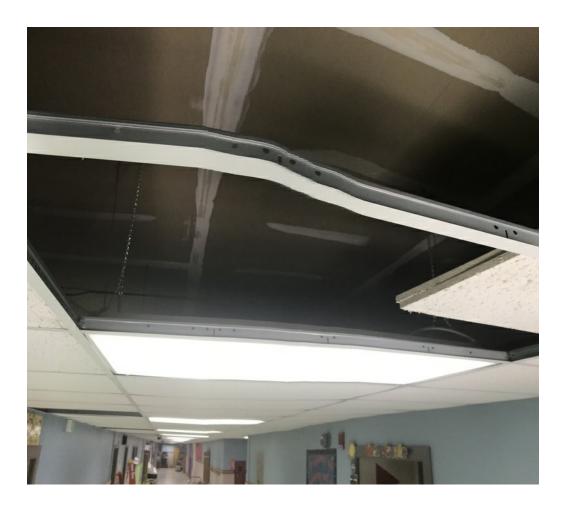
Figure 1-4. Damaged Ceiling Tile Track

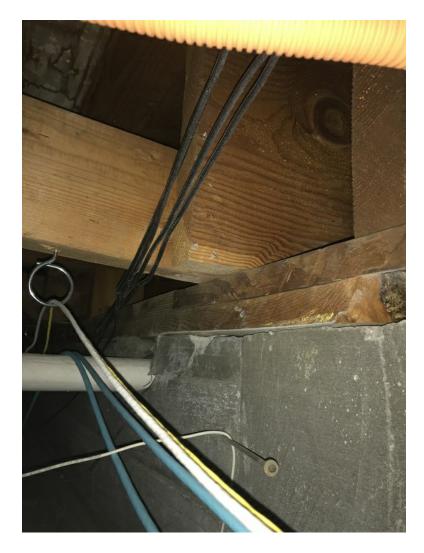
Figure 1-5. Lack of Connection Between Wood Framing and Concrete Wall

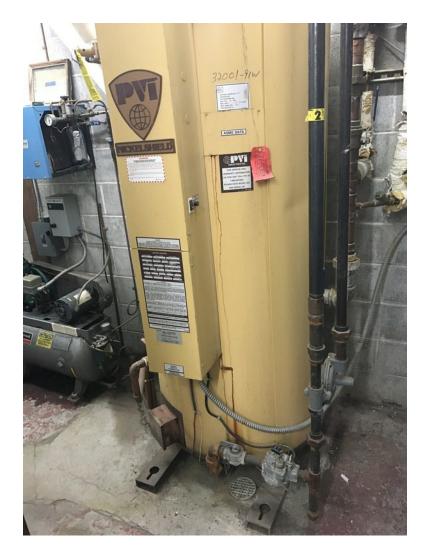
Figure 1-2. Unbraced Mechanical Equipment, Typical Throughout

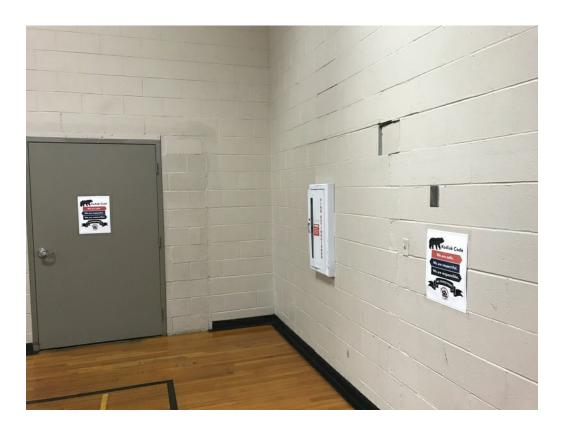
Figure 1-4. Damage to Interior CMU Walls

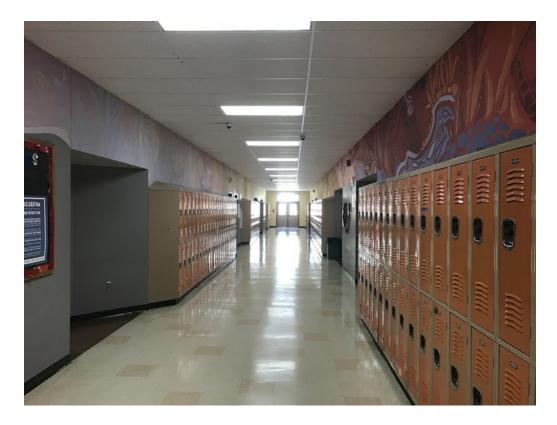
Figure 1-5. Typical Corridor with Unknown Light Fixture Bracing

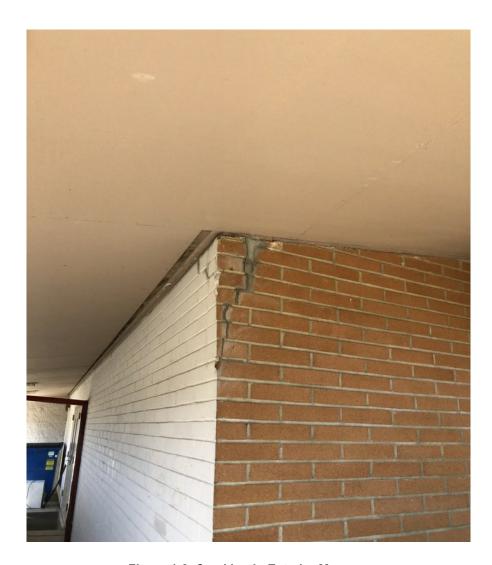
Figure 1-8. Cracking in Exterior Masonry
